English Barns

The first settlers (1760-1800) built English Style barns known as 30 by 40's, the approximate dimensions of the building. The barns featured three bays and a central door on the long side of the building. The simplest style is shown in the example below, probably built between 1784 and 1827 and was once attached to the house.

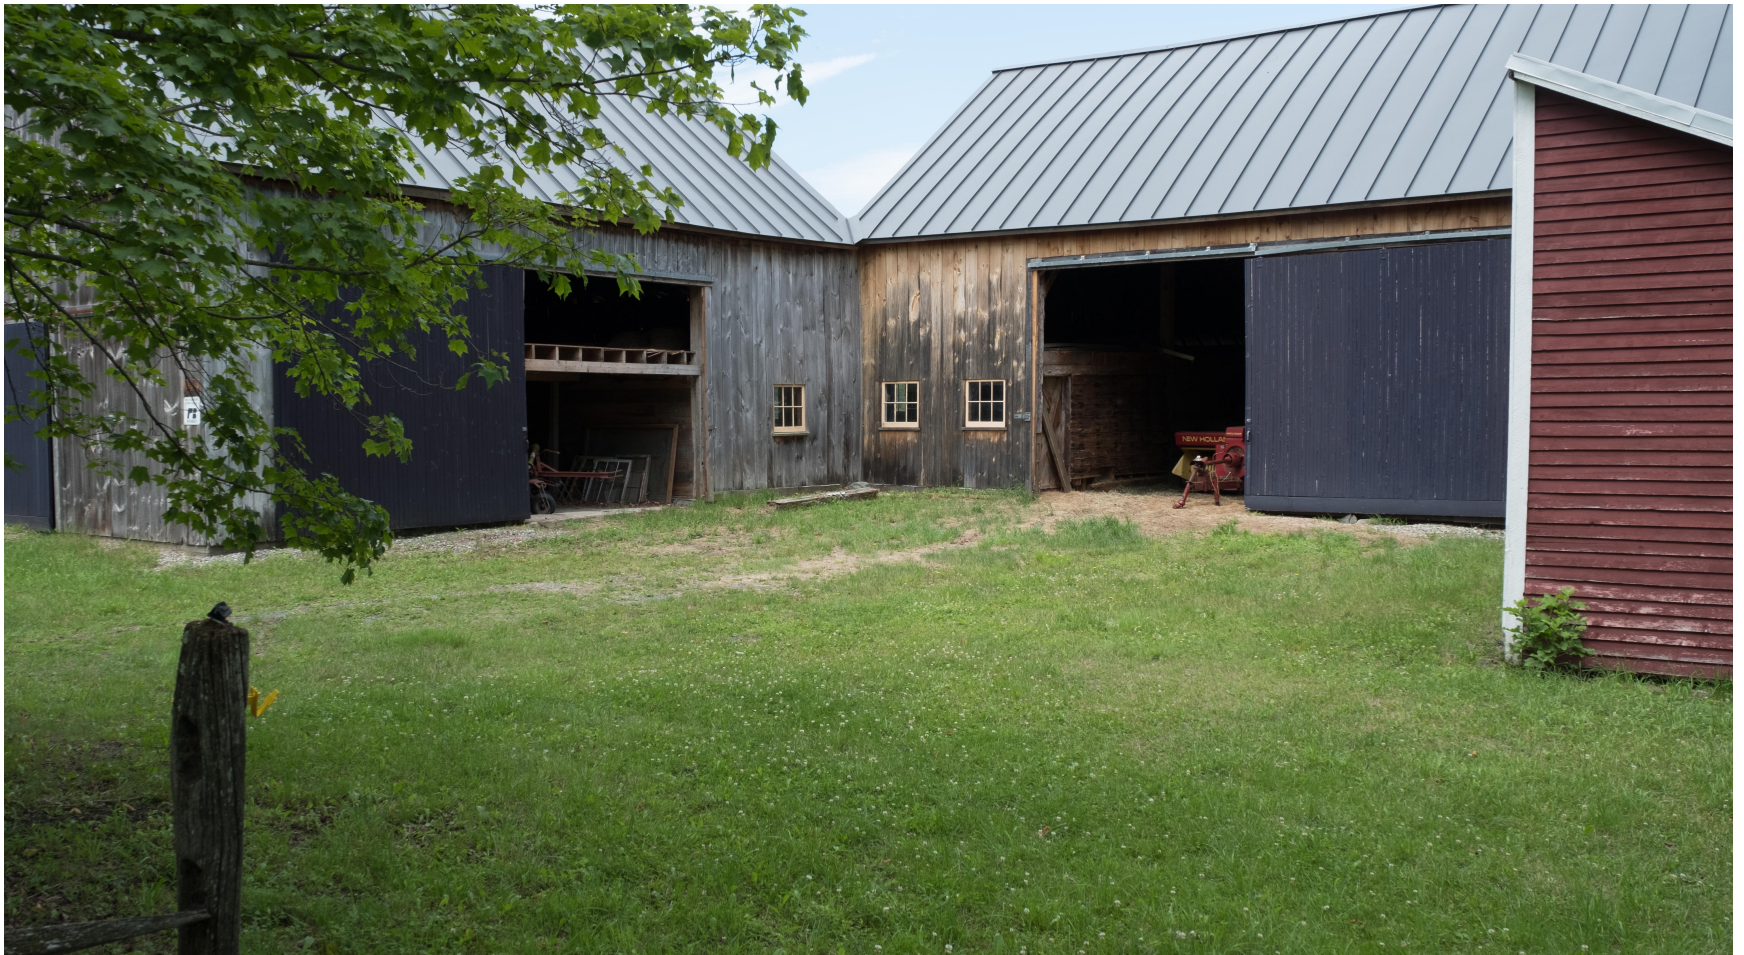
As necessity demanded, the configuration of the early English Style barns was modified. Modifications included additions at the gable ends, building into a bank and much later windows were added as glass became less expensive. This barn has a shed added to the gable end and windows that were probably added in the 19th Century.

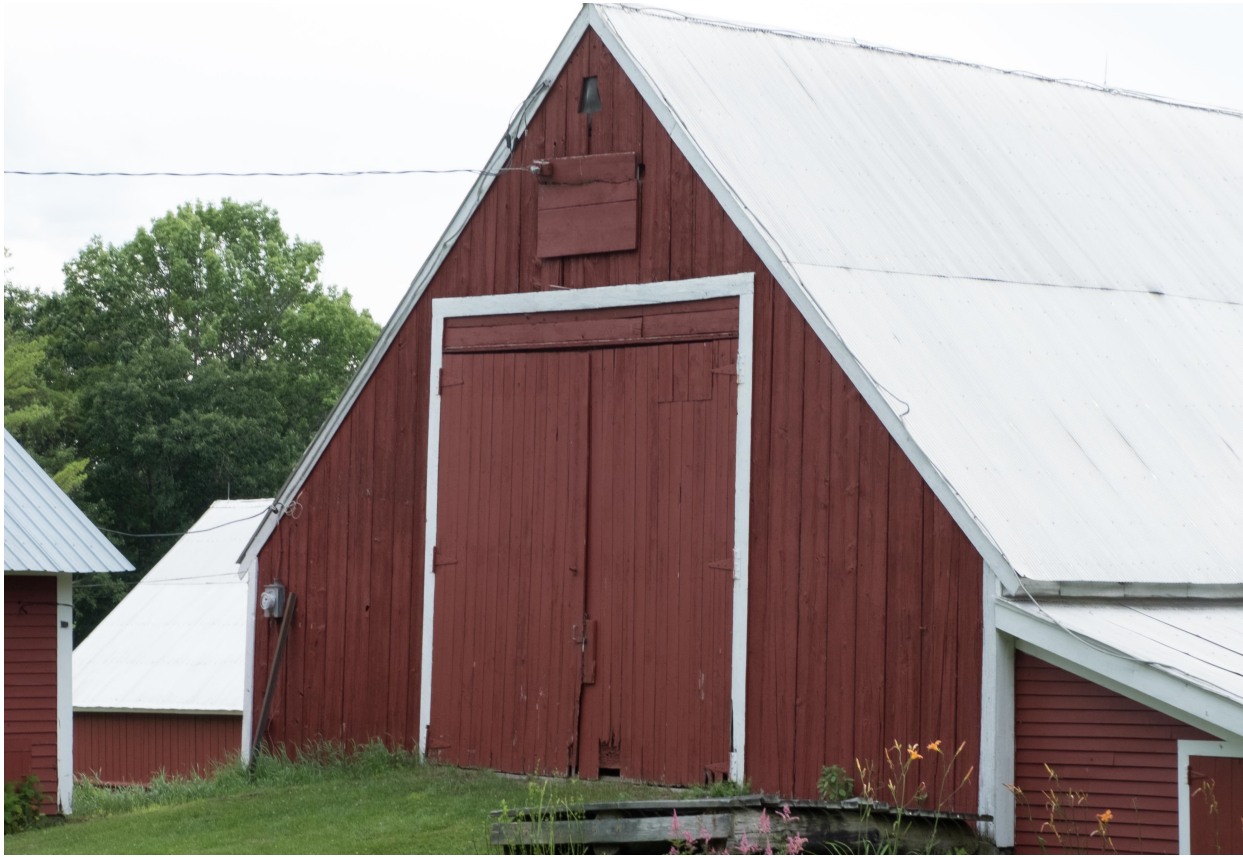
This English barn is built into a bank. The rear of the barn is open to allow livestock to enter the lower level to feed. There is a trap door in the upper floor, to allow hay and grain to be lowered for the animals below, saving labor.

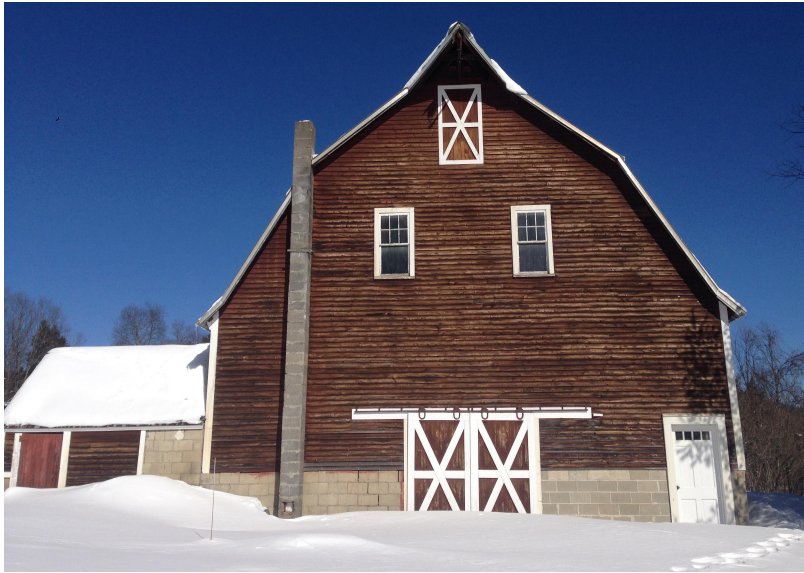
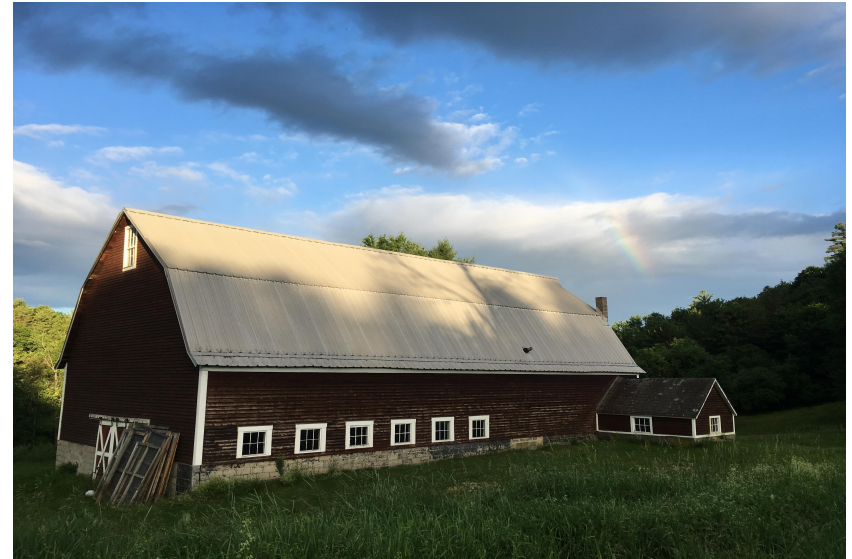
Example of a combined ramp barn and bank barn of post and beam construction dating from the mid 19th Century, about 1840. The attached buildings were added later.

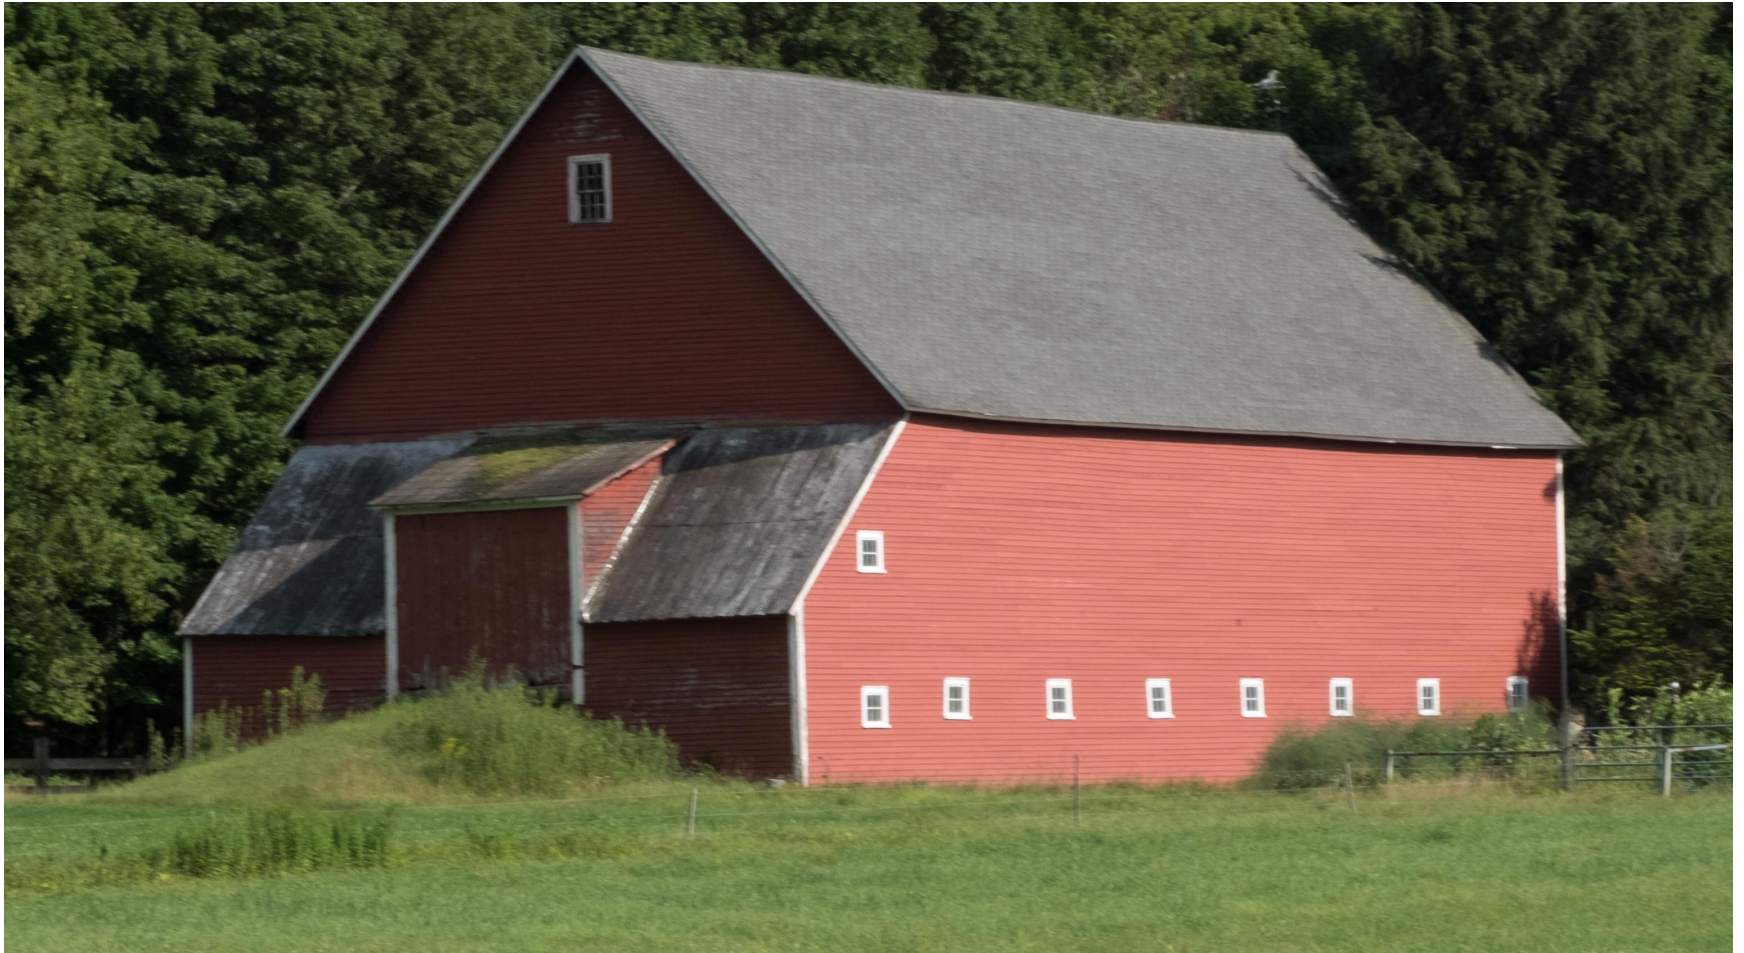
The gambrel style roof on this hay barn allowed for more internal storage space for hay and grain. Note the windows and the front and rear doors. The doors on opposite ends allowed the farmer to drive a hay wagon into the barn, unload and drive out the other end.

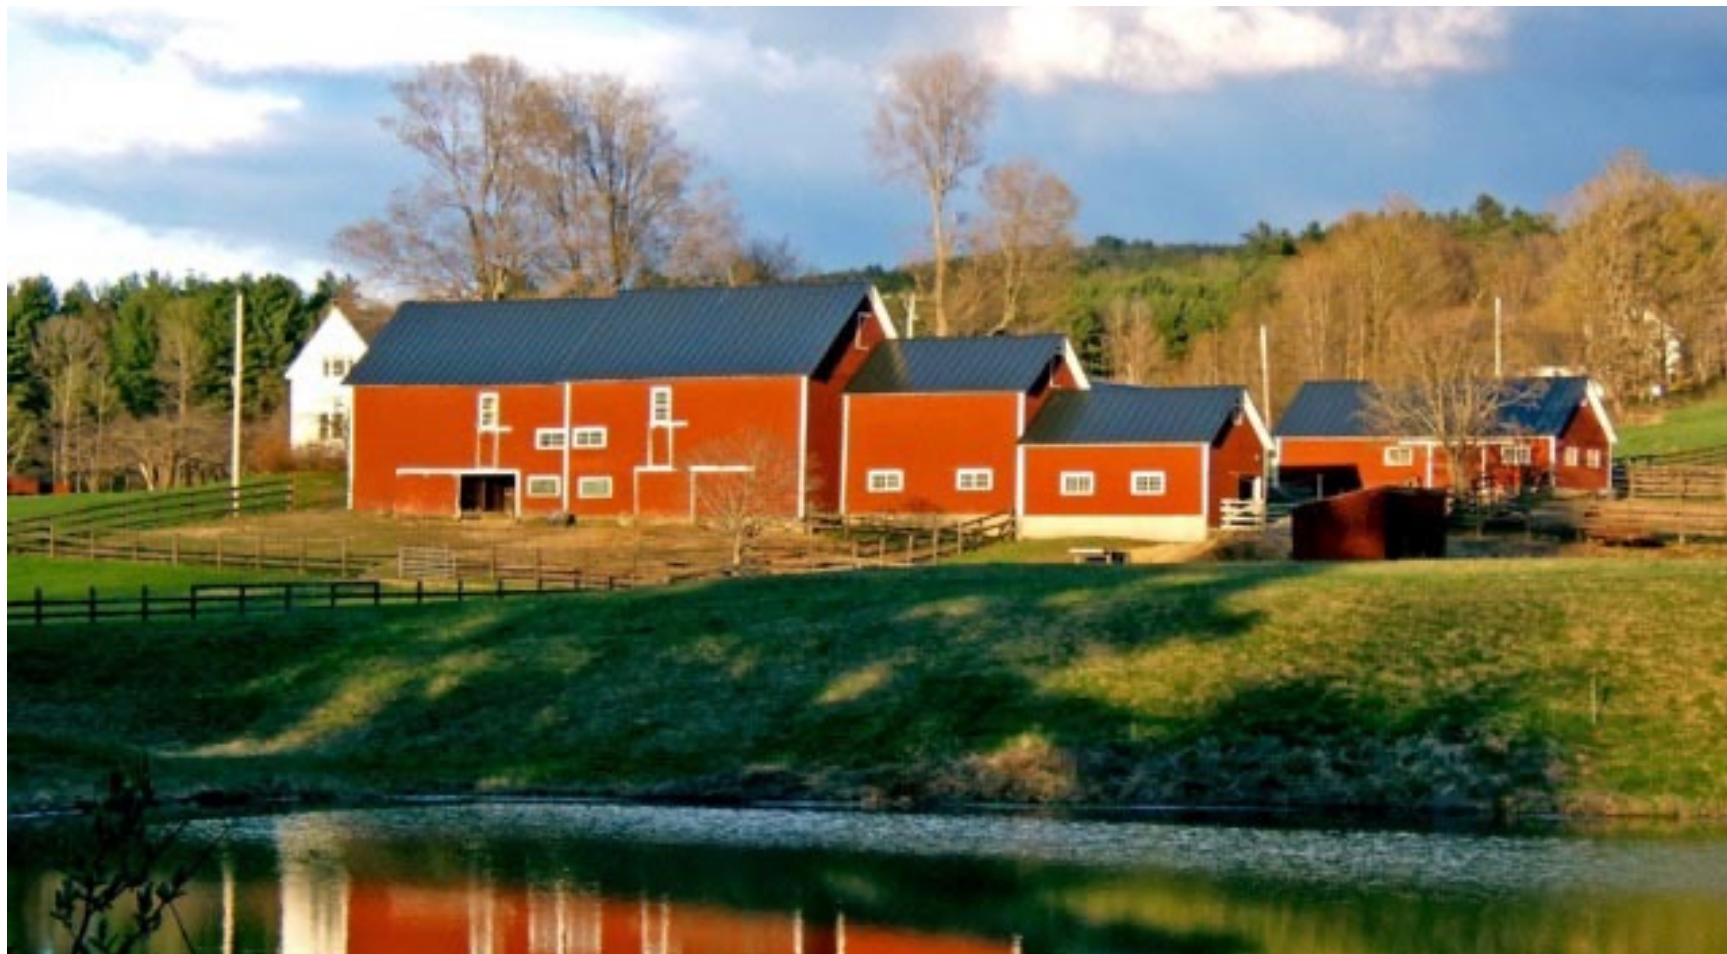
This late 19th Century barn is an excellent example of a ramp and drive through barn. These barns were a labor saving devices. A farmer could drive his hay wagon into the barn and unload to the lower level, gravity doing a large part of the work. Note the added windows to allow light to enter the lower level.

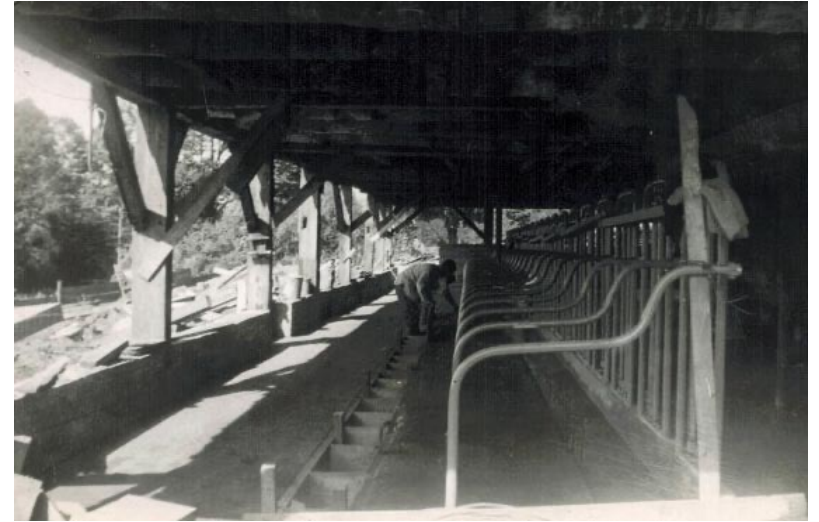
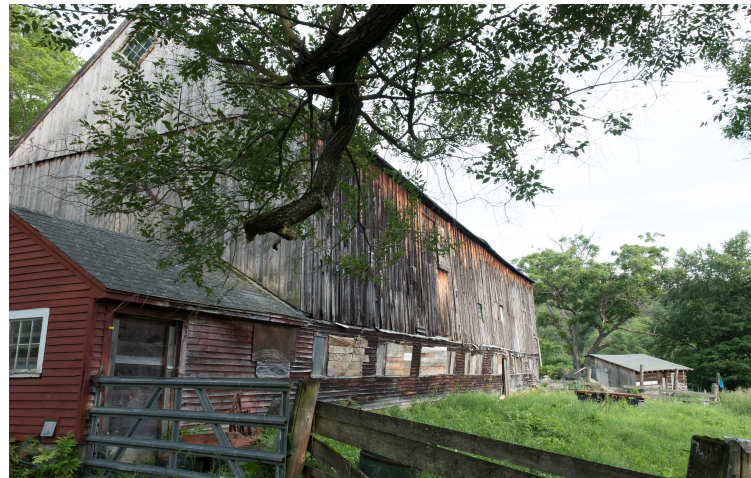
Example of a Bank Barn: the original part was probably built around 1798 with additions made until the 1950's. Clock wise from the upper left: the barn being reconfigured (1954) to provide space for a milk house and stalls under the barn and last as it stands today.

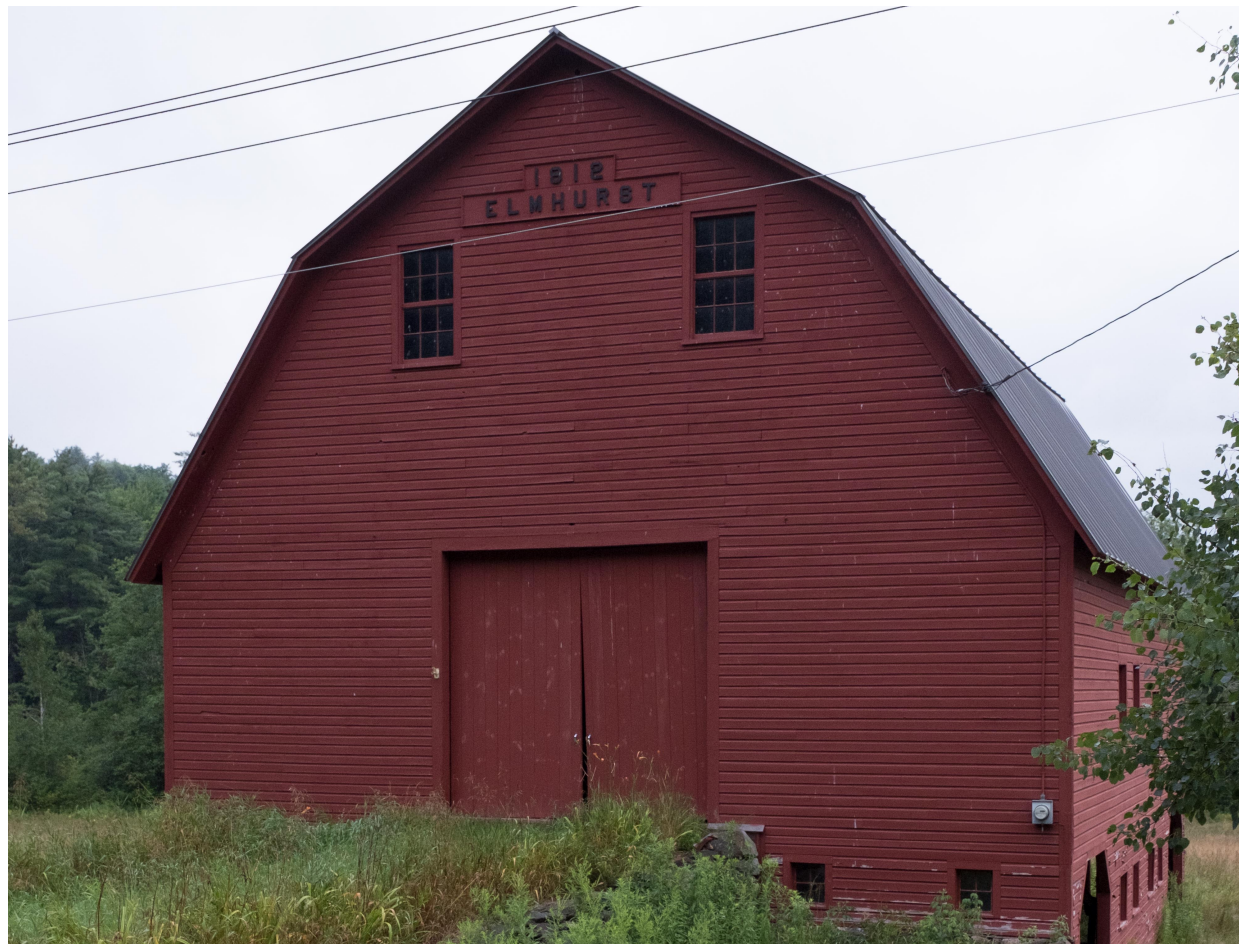
The 1912 Elmhurst barn, know as the Cornish Recreation Area (CREA) Barn was restored by Cornish volunteers and repurposed as an event venue and field house for the recreation area. The CREA barn is a fine example of a gambrel roof barn. Until 1971 when the company was dissolved, this barn was the home of the Whitcomb Lobster Trap Factory.

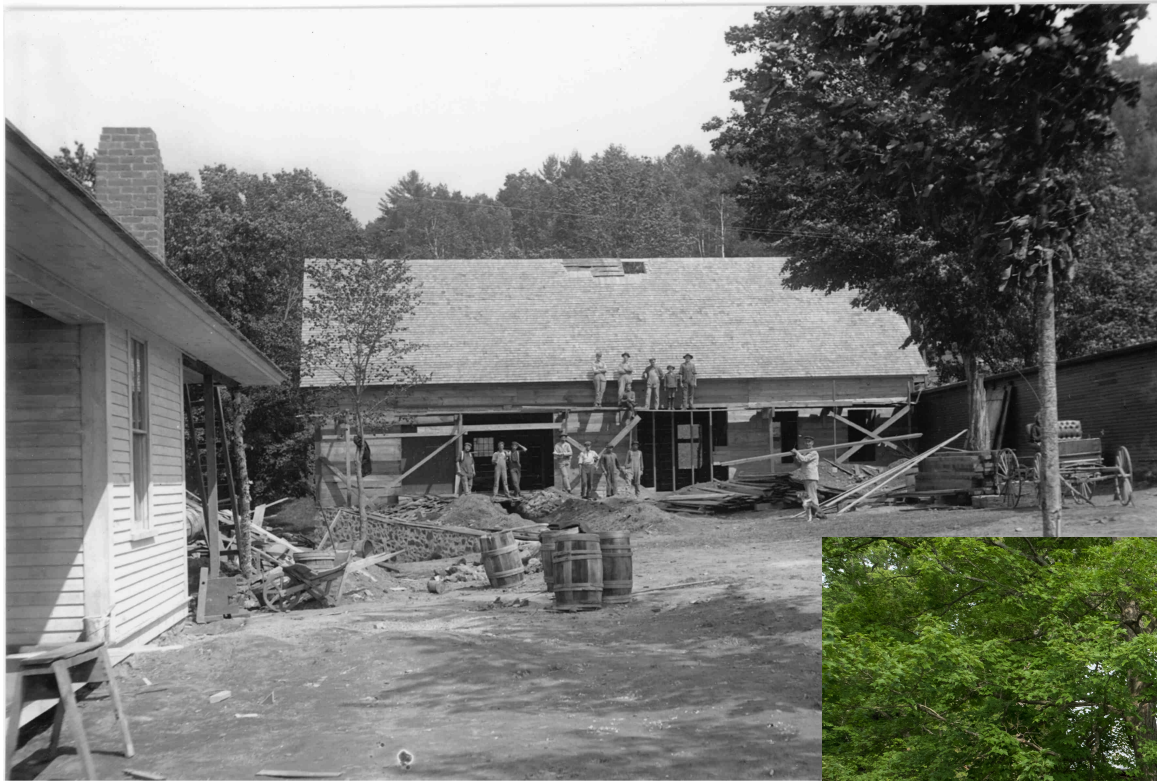
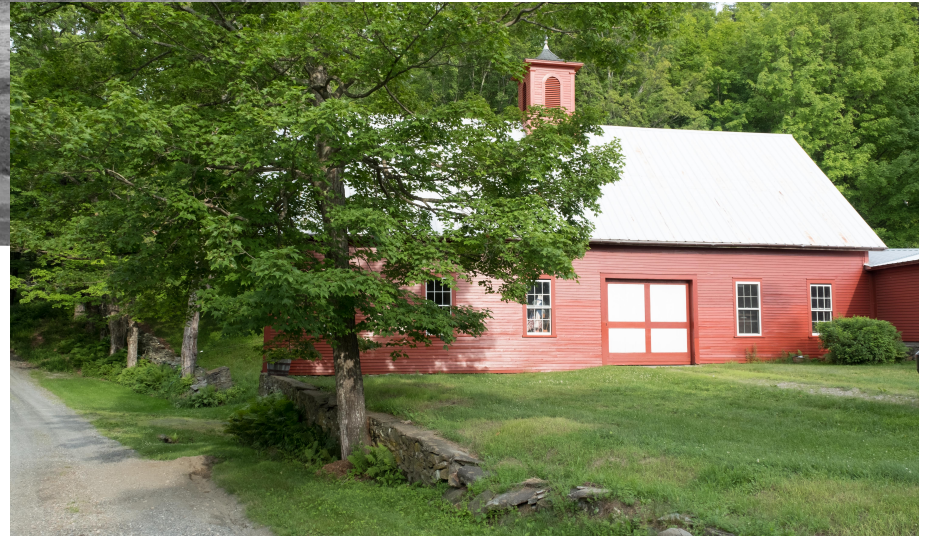
The black and white photograph (top) shows this cow barn during renovation. The original barn probably built in the late 19th Century was converted to a horse barn in 1903 as it is today (lower photo).

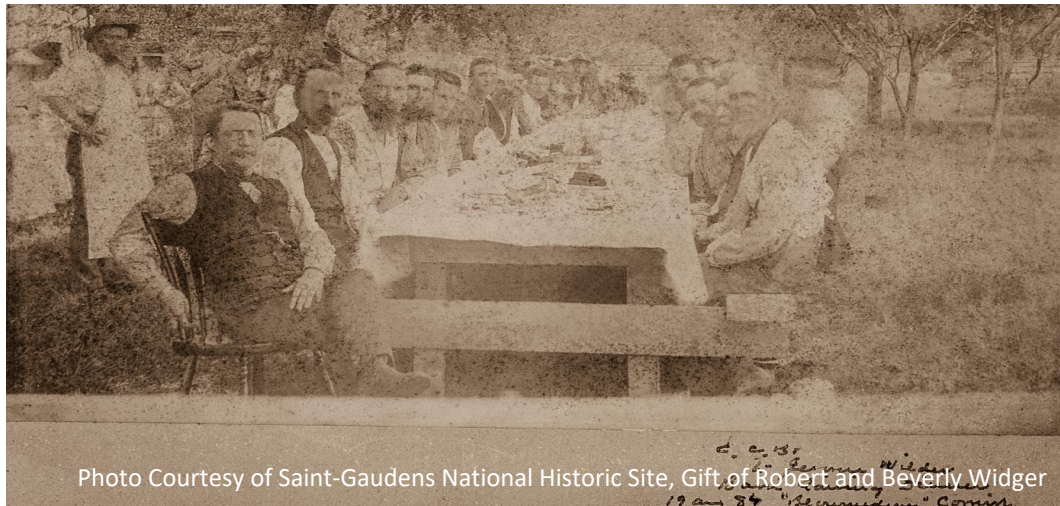
Barn Raising on Blow-Me –Down Farm July 28, 1884. This four story barn is and example of post and beam construction. Also (lower) shown is the dinner given by Charles Beaman family for all those who helped raise the barn including Jerome and James Wilder.
